# **TROUBLE SHOOTING VIKING DELUGE VALVES**

# TROUBLESHOOTING THE VIKING MODEL D, D-2, D-4 AND D-5 DELUGE VALVES

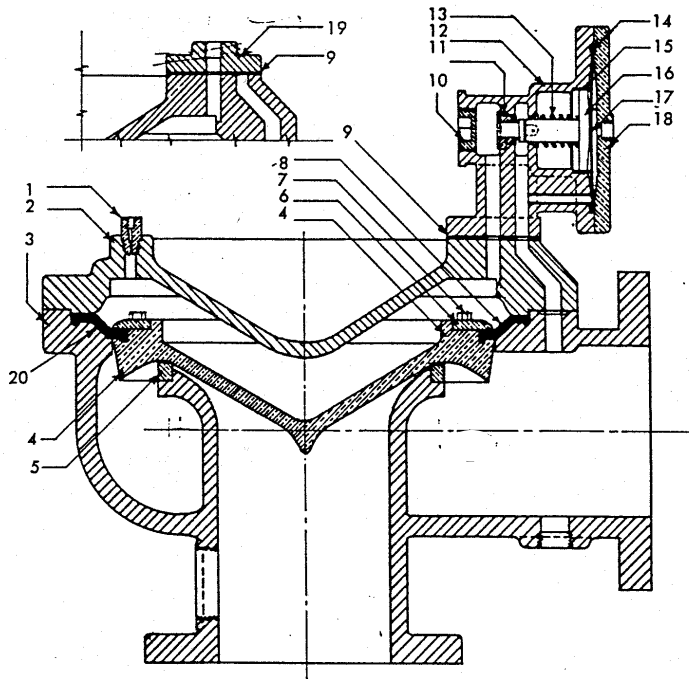
## MODEL D CONTROL VALVE DIFFERENTIAL TYPE

Diaphragm bypass valve has standard 1/2" pipe tap in cover plate for release line.

Differential of diaphragm bypass valve is 5:1.

CONTROL VALVE DIFFERENTIAL  
2....Approx. 4:1  
3....Approx. 3:1  
4....Approx. 3:1  
6....Approx. 2:1

### GENERAL ASSEMBLY OF VIKING MODEL D CONTROL VALVE WITH DIAPHRAGM BYPASS VALVE

NOTE: Arrangement of parts same for all sizes.  
For hydraulic and electric release systems, use adapter plate No. 19.  
For pneumatic release systems, use diaphragm bypass valve, parts No. 10 to 18 inclusive.

The Viking Model D, D-2, D-4 and D-5 deluge valves are very similar in operation, therefore they will all be covered as being in one section of the troubleshooting guide. The “D” series of Viking Deluge valves all have a priming chamber on top of the valve, an outlet chamber (the bowl of the valve), and an inlet chamber from the inlet flange to the underside of the clapper. They all use water pressure in the priming chamber to hold the valve closed, and the area above the clapper is twice the area of the waterway under the clapper. This means that if the water pressure is the same above the clapper as it is below the clapper, then there is a 2:1 mechanical ratio holding the clapper closed.

Therefore, in order to trip a Viking deluge valve, the priming chamber must be vented more quickly than the priming water can be replaced, in order to destroy the 2:1 differential of the priming chamber. The priming chamber can be vented pneumatically (by means of a Pneumatic Actuator), hydraulically (by means of a wet pilot line), or electrically, (by means of a solenoid valve and release control panel). Any one of these methods will allow the priming chamber to be vented by opening a drain port that is larger than the restricted orifice that is located in the priming line which feeds priming water into the priming chamber.

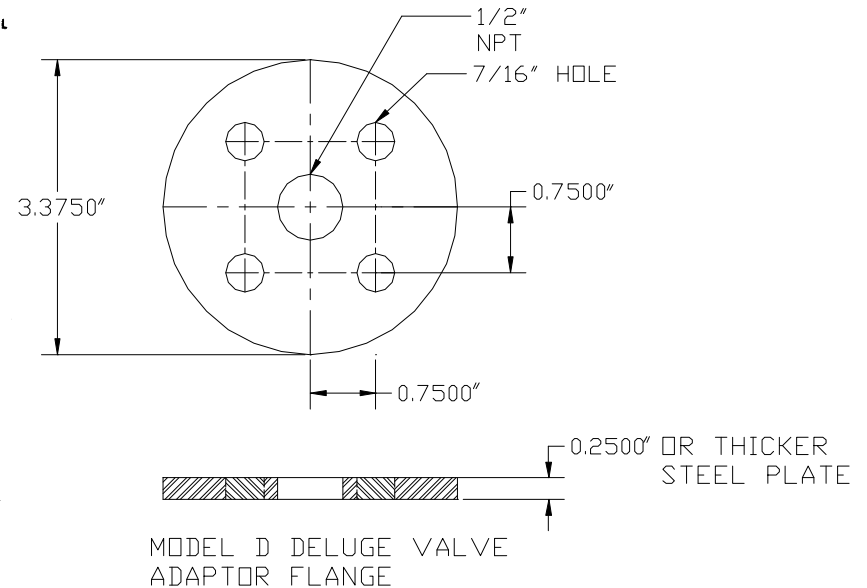
# VIKING MODEL D DELUGE VALVE WITH DIAPHRAGM BYPASS VALVE

WHEN REMOVING THE OLD DIAPHRAGM BYPASS VALVE, AN ADAPTOR FLANGE MUST BE FABRICATED IN ORDER TO ADAPT A PNEUMATIC ACTUATOR TO THE VALVE TRIM. SEE BELOW FOR DETAIL OF ADAPTOR FLANGE. MAKE THE GASKET FROM SHEET RUBBER STOCK.

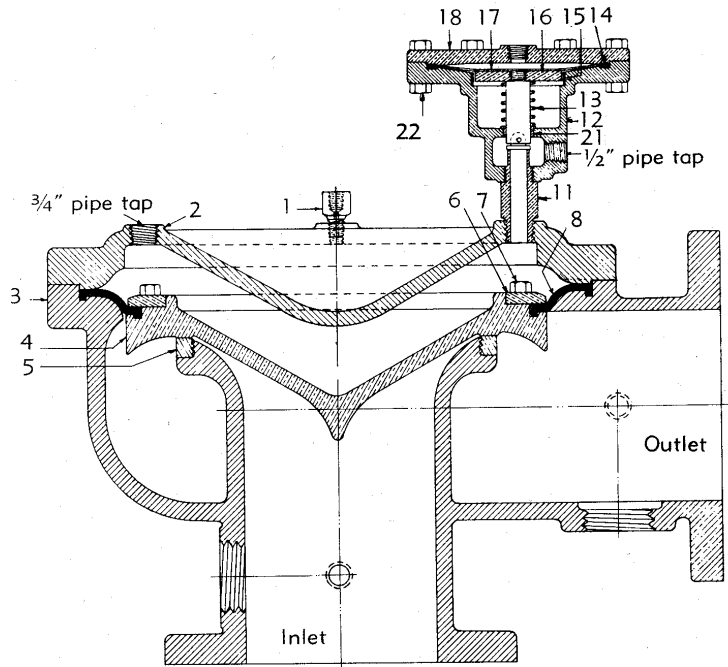
## MODEL D-2 CONTROL VALVE DIFFERENTIAL TYPE

Diaphragm bypass valve has standard 1/2" pipe tap in cover plate for release line.

Differential of diaphragm bypass valve is 5:1.

CONTROL VALVE DIFFERENTIAL  
 2....Approx. 4:1  
 3....Approx. 3:1  
 4....Approx. 3:1  
 6....Approx. 2:1

### GENERAL ASSEMBLY OF VIKING MODEL D2 CONTROL VALVE WITH MODEL D2 DIAPHRAGM BYPASS VALVE

NOTE: Arrangement of parts same for all valves  
 For PNEUMATIC release systems always use a diaphragm bypass valve.  
 For HYDRAULIC release systems do not use a diaphragm bypass valve, but connect release line directly into top of cover.  
 For ELECTRIC release systems always use a magnetic bypass valve.

THE DIAPHRAGM BYPASS IS NO LONGER AVAILABLE. THE TRIM PIPING MUST BE MODIFIED BY REMOVING THE DIAPHRAGM BYPASS AND INSTALLING A MODEL H-1 PNEUMATIC ACTUATOR AND THE NECESSARY NIPPLES AND FITTINGS IN ITS PLACE. A PORV MUST ALSO BE ADDED INTO THE TRIM.

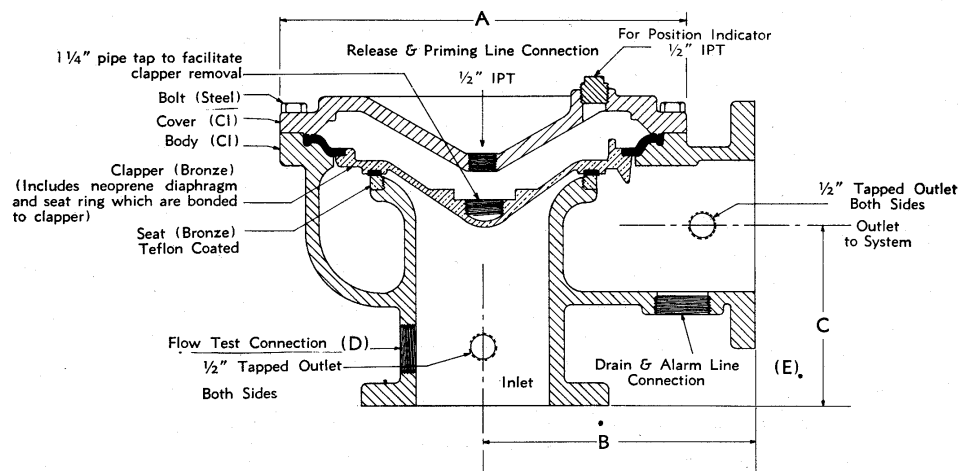
**VIKING DELUGE VALVE MODEL D-4**

The Model D-4 Valve has a rubber to metal seat which is a vast improvement over the D-2 and D-3. One 1/2" tap is provided in the center of the cover for the release and priming line connections. The bronze seat is replaceable on this model.

NOTE: 2" Valve has standard female pipe threads on inlet and outlet. Other sizes have standard flanges.

VALVE SIZE	A	B	C	D	E	APPROX. DIFF.	RECOMMENDED FLOW (GPM)
2"	8 1/4	*4 1/6	*3 3/6	3/4	3/4	2:1	0-250
3"	10 1/2	7	5	1 1/2	3/4	2:1	125-500
4"	13	8 1/2	6 1/2	2	1	2:1	250-1000
6"	18 1/4	12	8	2	1	2:1	750-3000

OPERATION: In set position equal pressure is maintained above and below the clapper through an orificed connection. Operation of release (manual or automatic) vents the pressure in the release line and the area above the valve. The pressure on the inlet side then forces the clapper up allowing water to enter the system.

RATING: 175 PSI working water pressure. Each valve factory tested at 350 PSI.

- The Viking model D-4 deluge valve was the first Viking Deluge Valve to have a rubber to metal seal at the clapper seat. It began being manufactured in 1972 and was produced up to 1985, depending upon the size of the valve. It used a bonded rubber for the clapper seal to the clapper seat. Should the clapper rubber need to be replaced, it needs to be replaced with a D-5 Deluge Valve clapper assembly. This way, for future clapper rubber replacement, the clapper rubber is field replaceable with a D-5 unit.

- The clapper assembly is fairly simple to access, enough of the trim has to be removed so that the cover can be easily removed. Once the cover is removed, there is direct access to the clapper assembly. It can be removed by prying the rubber diaphragm up and out of the groove in the top of the body of the valve, all the way around the valve, and then lifting the clapper assembly out of the valve. Replace the removed clapper assembly with a D-5 clapper assembly. This is also a good time to check the clapper seat inside the valve to make sure it is not damaged in any way. If there are very slight scratches, or similar minor damage to the valve seat, Emory cloth can be used to smooth out the damaged area(s). If the seat is damaged to a point where it is too deep to allow for a consistent seating of the valve clapper, and light use of Emory cloth will not work in this case, then the valve needs to be replaced, because the valve seat is not replaceable.

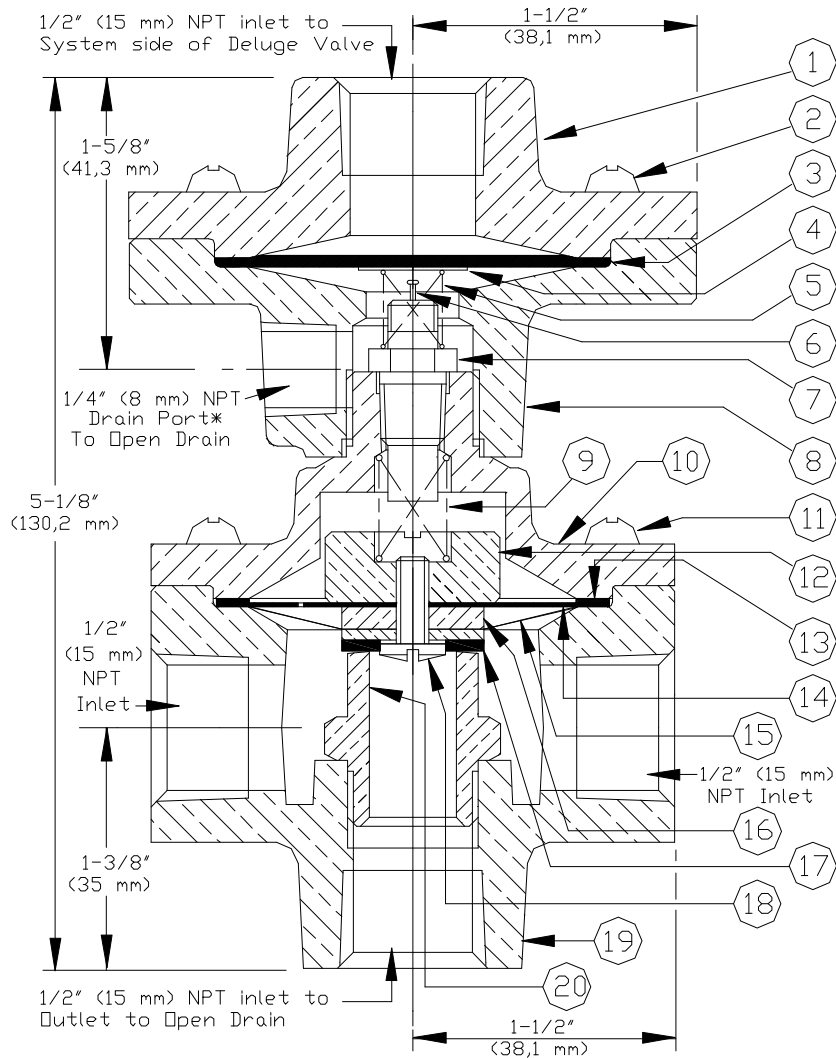
# VIKING MODEL C-1 P.O.R.V.

\* Orientation of 1/4" outlet axis may vary relative to axis of 1/2" inlet ports.

ITEM NO.	PART NUMBER	DESCRIPTION	MATERIAL	NO. REQ'D.
1	01937B	Cover	Brass	1
2	04505A	R.H. Screws #10-24 UNC x 5/8" lg.	Stainless Steel	6
3	*	Diaphragm	Neoprene	1
4	*	Diaphragm Disc	Stainless Steel	1
5	04137A	Spring	Stainless Steel	1
6	*	Schrader Core	Brass, Nickel Plated	1
7	*	Schrader Body		1
8	01938B	Base	Brass	1
9	06177A	Spring	Stainless Steel	1
10	06426B	Cover	Brass	1
11	04505A	R.H. Screws #10-24 UNC x 5/8" lg.	Stainless Steel	6
12	*	Spring Retainer	Brass	1
13	*	Seal Ring	Neoprene	1
14	*	Diaphragm	Nylon Reinforced Neoprene	1
15	*	Clamp Plate	Brass	1
16	*	Screen	Monel	1
17	*	Clapper	Brass with Bonded Neoprene	1
18	*	Screw	Brass	1
19	*	Body	Brass	1
20	-	Seat	Brass	1

3,4	01792A	Diaphragm Assembly
6, 7	06418A	Schrader Valve
12-18	01828A	Diaphragm Assembly Repair Kit
19, 20	03709B	Body Assembly

The Viking Model C-1 P.O.R.V. is a field serviceable part that is made up of various components as indicated on the previous page. This device is essentially a hydraulic latch which holds the valve open, even when using resettable detection devices. It has been manufactured since 1966.

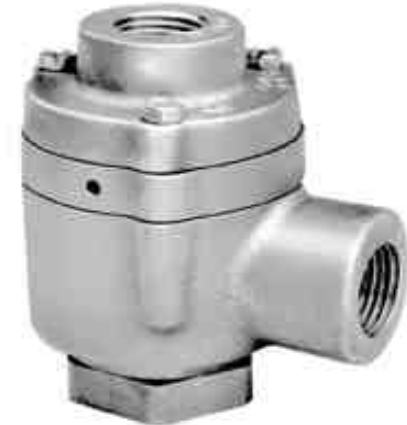
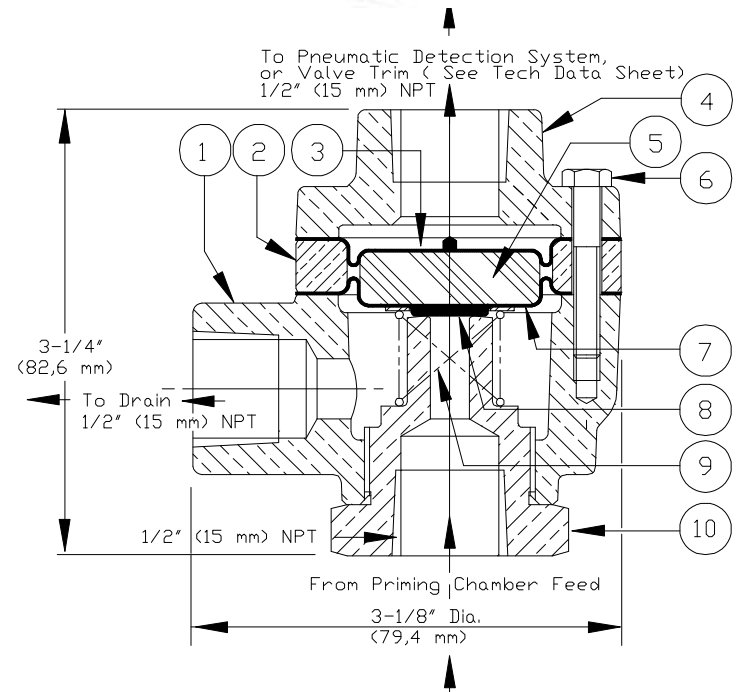
# VIKING MODEL H-1 PNEUMATIC ACTUATOR

Item No	Part No	Description
1	None	Body
2	None	Spacer
3	04735A	Upper Diaphragm
4	None	Cover
5	04736A	Piston
6	04732A	H.H.S. #10-24 x 1 1/4"
7	04861A	Lower Diaphragm
8	04739A	Spring Pad
9	04741A	Spring
10	06464B	Seat

The Viking H-1 and R-1 (corrosion resistant model) are both spring loaded to open, rolling diaphragm, piston operated valves. They are used wherever a separation is required between the detection and operating systems.

This H-1 has been manufactured since 1986, and the R-1 has been manufactured since 1996. There is a factory drilled weep hole drilled into the spacer (item 2 in the sections of both the H-1 and the R-1). The weep hole is there to identify either an air leak or water leak in the device.

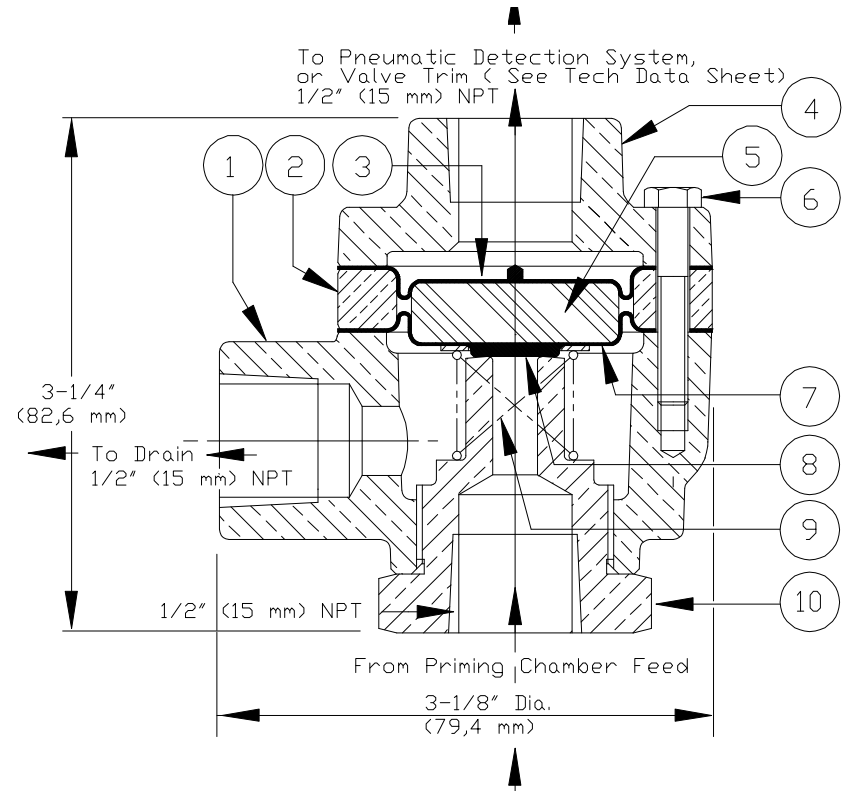
# VIKING MODEL R-1 PNEUMATIC ACTUATOR (CORROSION RESISTANT MODEL)

Item No	Part No	Description
1	None	Body
2	None	Spacer
3	04735A	Upper Diaphragm
4	None	Cover
5	04736A	Piston
6	06228A	H.H.S. #10-24 x 1 ¼"
7	04861A	Lower Diaphragm
8	06227A	Spring Pad
9	06224A	Spring
10	06464BJ	Seat

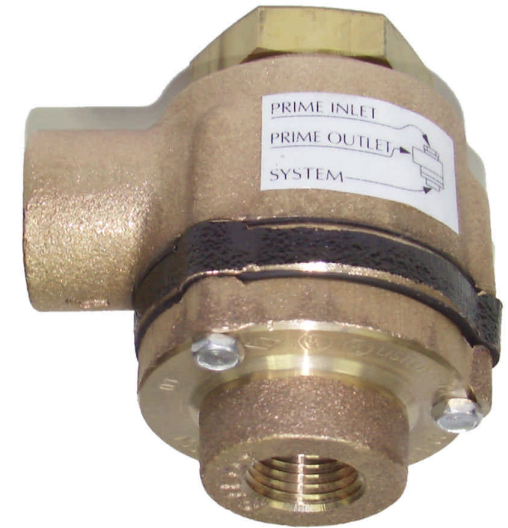
# VIKING MODEL A-1 PRIMING SHUT OFF VALVE

ITEM NO.	PART NUMBER		DESCRIPTION	MATERIAL		QTY REQ'D
	10723	10724		Model A-1	Model A-2	
1	--	--	Body	Brass, UNS-C84400	Brass*, UNS-C84400	1
2	--	--	Spacer	Brass, UNS-C84400	Brass*, UNS-C84400	1
3	04735A	04735A	Upper Diaphragm	EPDM/Polyester Fabric	EPDM/Polyester Fabric	1
4	--	--	Cover	Brass, UNS-C84400	Brass*, UNS-C84400	1
5	04736A	04736A	Piston	Polycarbonate	Polycarbonate	1
6	04732A	06228A	Hex Head Screw, #10-24 x 1-1/4" Lg.	Steel, Zinc Coated	Stainless Steel, UNS-S31600	3
7	04861A	04861A	Lower Diaphragm	EPDM/Polyester Fabric	EPDM/Polyester Fabric	1
8	04739A	06227A	Spring Pad	Stainless Steel UNS-S30200/UNS-S30400	Monel #400	1
9	04741A	06224A	Spring	Stainless Steel UNS-S30200	Inconel #600	1
10	06464B	06464BJ	Seat	Brass, UNS-C36000	Brass**, UNS-C36000	1

\* Electroless Nickel plated, Model A-2 only, Specification No. SPF02-J01.  
 \*\*Electroless Nickel and tin plated, Model A-2 only, Specification No. SPF-02-J07.  
 -- Indicates part is not available.

The Viking A-1 and A-2 (corrosion resistant model) PSOV's are both spring loaded to open, rolling diaphragm, piston operated valves. They are a main component of EZ trim, and are used to positively shut off the priming water to a deluge valve upon valve operation.

The A-1 has been manufactured since 1999, and the A-2 has been manufactured since 1999. There is a factory drilled weep hole drilled into the spacer (item 2 in the sections of both the A-1 and the A-2). The weep hole is there to identify a water leak in the device.
